Manhole Inspection Summary

Manhole # S25AA_021MH

Insp Date: **4/16/09 12:16 PM**

Location Address: **909 FREMONT AVE**

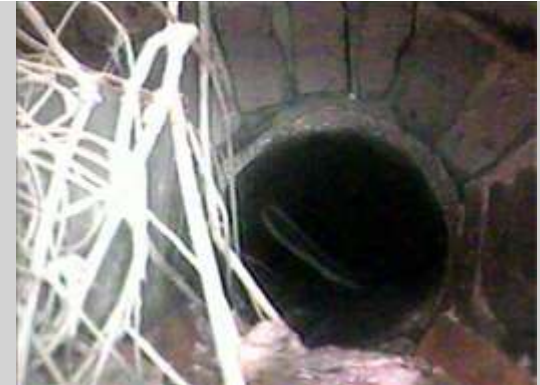
12 O'Clock Outflow

8 in. Circular Gravity Sewer
Pipe Out @ 12 O'Clock

Pipe Material: **Clay** ☐ Pipe Lined

Invert Depth: **9.60** (ft.) Flow Characteristics: **Slow**

Deposits: ☒ None ☐ Mud ☐ Sludge ☐ Debris ☐ Grease

Infiltration: **None** Pipe Seal Cond: **Sound**

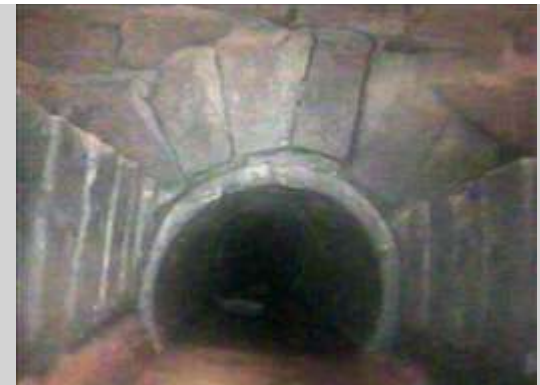
6 O'Clock Inflow

8 in. Circular Gravity Sewer
Pipe In @ 6 O'Clock

Pipe Material: **Clay** ☐ Pipe Lined

Invert Depth: **9.53** (ft.) Flow Characteristics: **Slow**

Deposits: ☒ None ☐ Mud ☐ Sludge ☐ Debris ☐ Grease

Infiltration: **None** Pipe Seal Cond: **Sound**

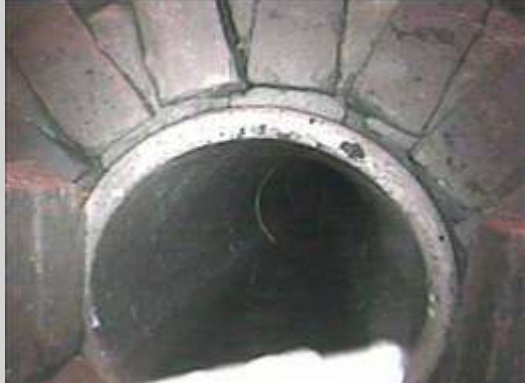
9 O'Clock Inflow

8 in. Circular Gravity Sewer

Pipe In @ 9 O'Clock

Pipe Material: **Clay** ☐ Pipe Lined

Invert Depth: **9.57** (ft.) Flow Characteristics: **None**

Deposits: ☒ None ☐ Mud ☐ Sludge ☐ Debris ☐ Grease

Infiltration: **None** Pipe Seal Cond: **Sound**
